Commonwealth of Pennsylvania  
Department of Environmental Protection  
September 4, 2026

Subject: Aquatic Biology Investigation  
Case: Shull Farm FPR Operation  
UNT Geddes Run  
Plumstead Township, Bucks County

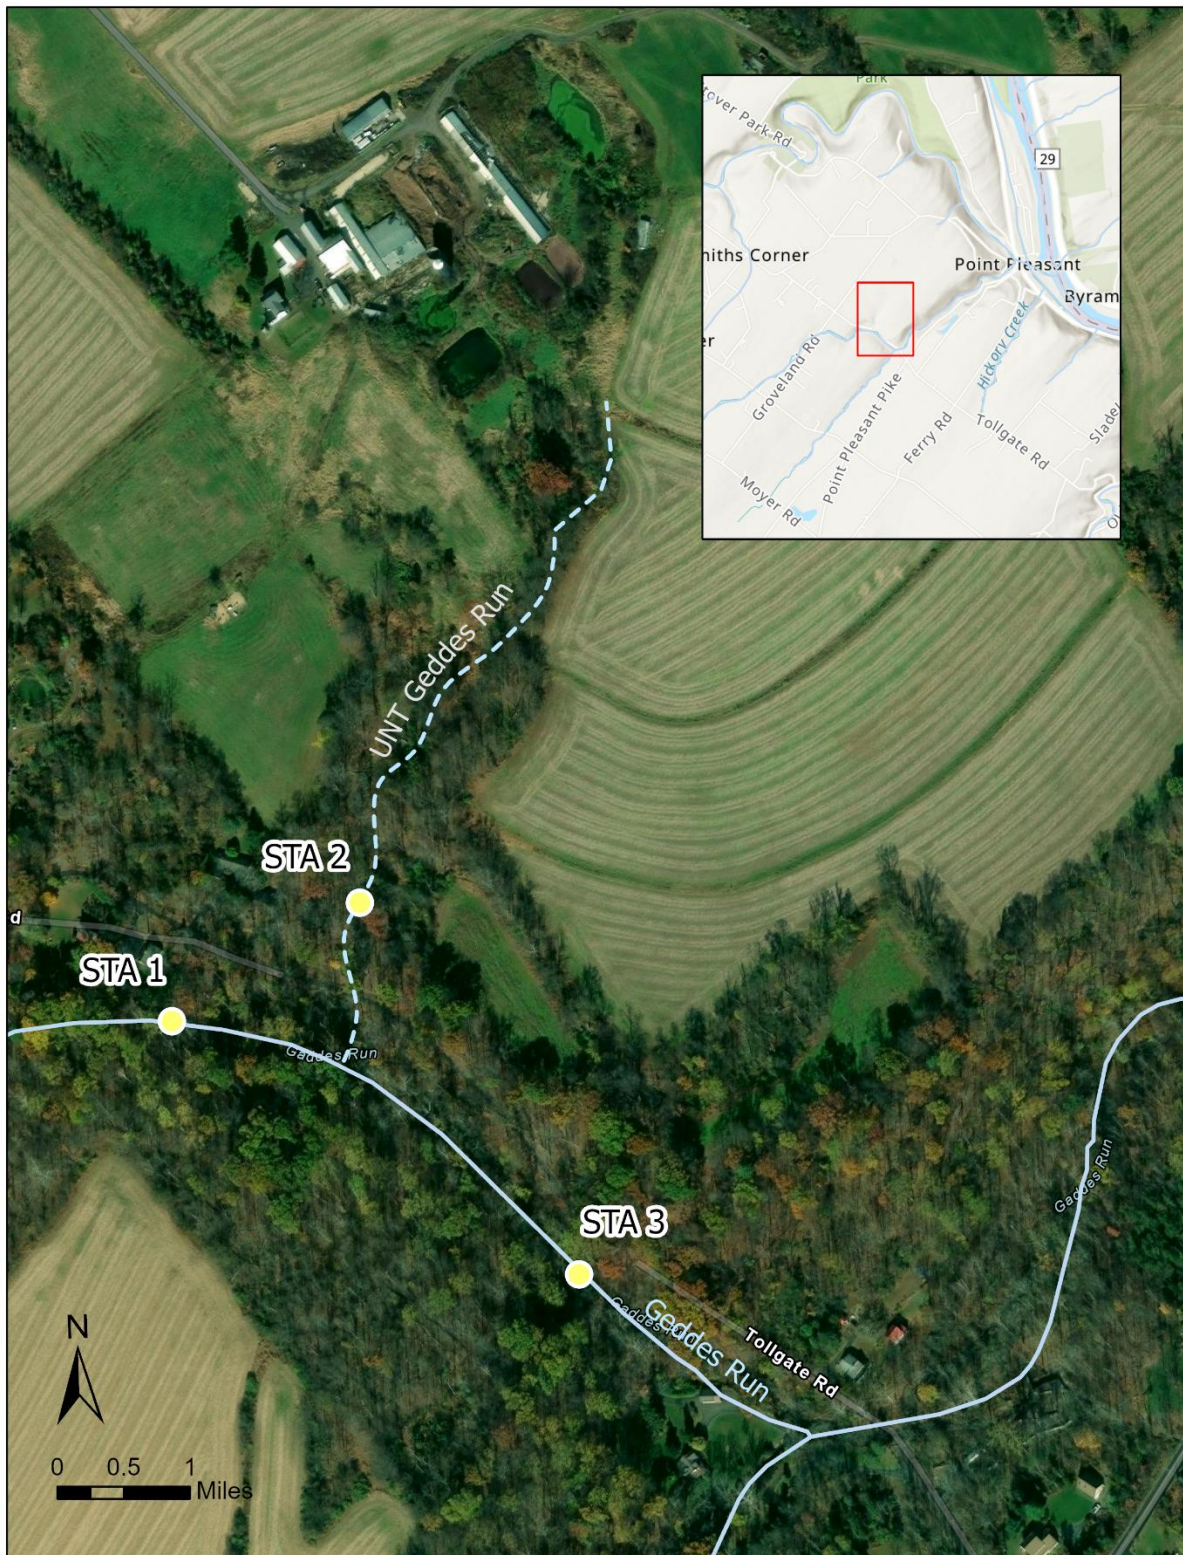
Figure 1. Aerial imagery showing station locations. Solid blue lines are NHD Plus V2 flowlines. Dashed blue line added by author.

STA1 was selected as an upstream reference station on Geddes Run (Figure 1). The station was located approximately 100m above the confluence with the UNT receiving flow from seeps near the base of the lagoons and adjacent fields where FPRs were applied. Conditions seemed as expected with no abnormal odor, color, turbidity, deposits, or foam observed. Field chemistry results were normal with pH and dissolved oxygen within specific water quality criteria (Table 1). Specific Conductivity was typical of streams in the region. Results from samples sent to the lab showed elevated total phosphorus, typical of the region, and metals and other parameters within specific water quality criteria and criteria for toxic substances (Table 2). Nitrogen and phosphorous were slightly lower at STA1 than STA3.

STA2 was located on the receiving channel on the farm property approximately 100 meters upstream of the confluence with Geddes Run (Figure 1). This station was selected to represent conditions below the impacts from the FPR composting area, manure storage, and runoff from fields where FPRs are applied. Observations were made starting at the beginning of the channel

STA3 was selected to assess downstream impacts (Figure 1). The station was located approximately 100m below the confluence with the receiving stream. No abnormal odor, color, turbidity, deposits, or foam were observed. Field chemistry results were similar to STA1 (Table 1). Water chemistry results showed total phosphorus and nitrogen were slightly elevated compared to STA1 but not as high as STA2. Phosphorus and nitrogen remained slightly higher

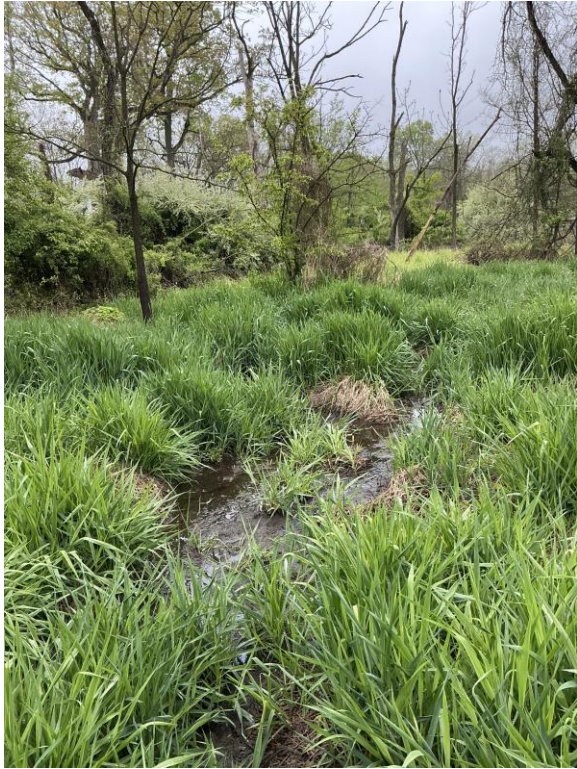
Photo 1: Beginning of channel behind impoundments

below the lagoons downstream to STA2 (Photo 1). Dark colored seeps were seen beginning near the base of the lagoons along with a pooled area with two corrugated pipes (Photo 2). The seeps led to a continuous channel containing undesirable algal growth including gray filamentous material indicative of sewage fungus (*Sphaerotilus*) (Photo 3). A sharp drop in DO was documented by field meter upstream of a substantial grade control feature at the upstream extent of STA2 (Table 1). Below the grade control feature, flow increased and channel substrates were a mix of bedrock, cobble, and gravel. Seeps with clear water in areas away from the base of the lagoons were observed contributing to flow in the channel.

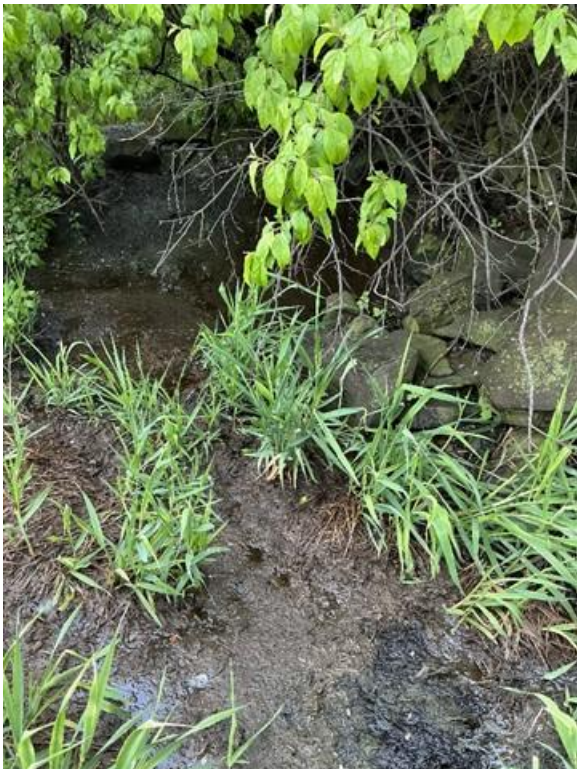
4. Increased organic and nutrient load originating from seeps at the base of the storage lagoons are likely the cause of undesirable biofilm and algal growth throughout most of UNT Geddes Run and reduced dissolved oxygen before the change in grade.

Photo 3: Undesirable algal growth in channel

1. The entire length of UNT Geddes Run should be included in the FPR waste management plan as a stream requiring minimum setback distances.
2. FPR storage structures, including the clay lined lagoons, should be inspected for seepages and integrity to prevent pollution of local water resources and avoid creating nuisance conditions.

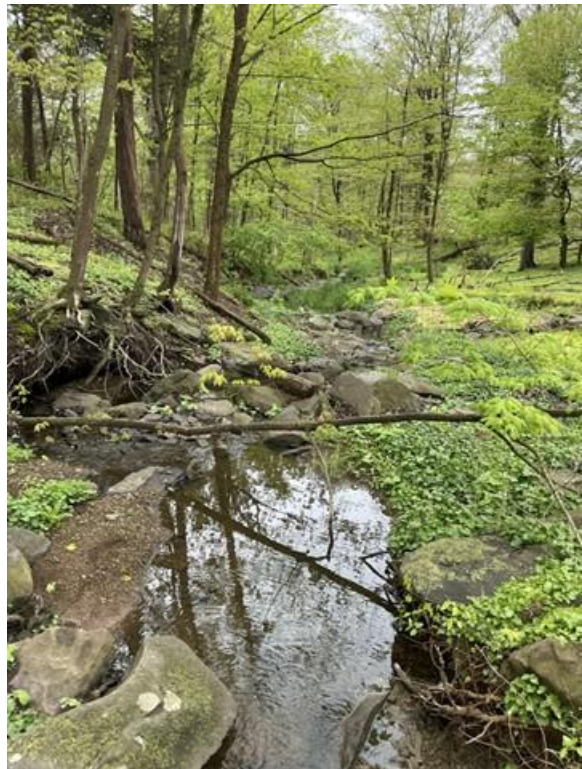
Photo 4: STA2 downstream view
